POOL FENCE TEST NO: AZT0036.14

# **POOL FENCE TEST REPORT**

**Client: Sentrel Pty Ltd**

**Model No. / Name:** Sentrel Pool Fence (Timber)

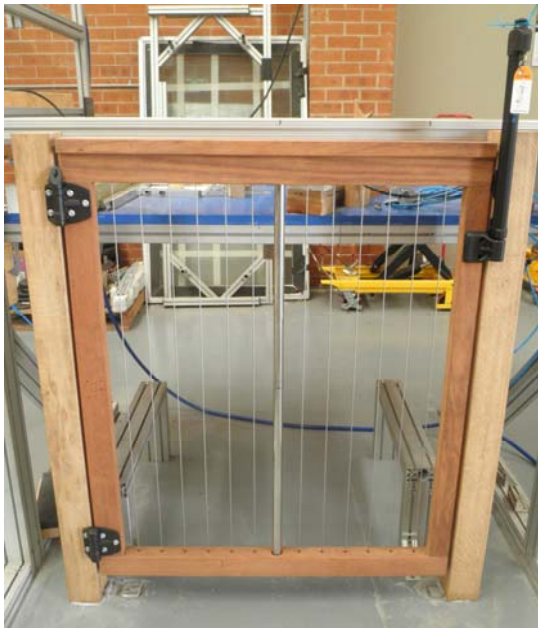
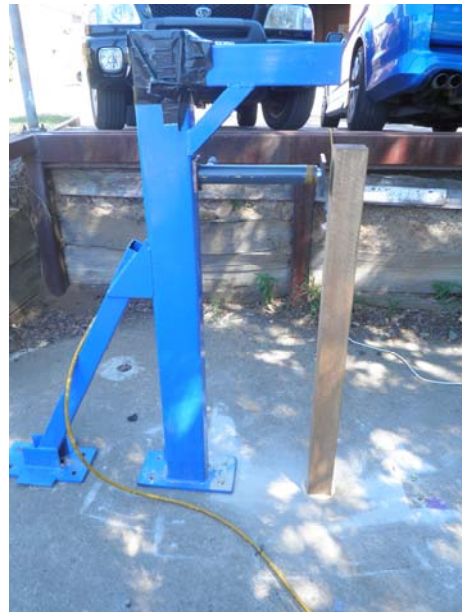
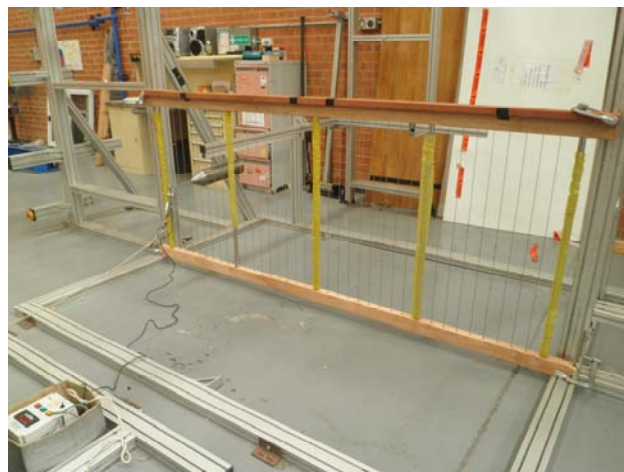
**Material-** Timber top & bottom rails with vertical Ø2.5mm SS316 cable and Ø25.4mm vertical divider tubes.

**Overall -** 2640mm W x 1170mm H

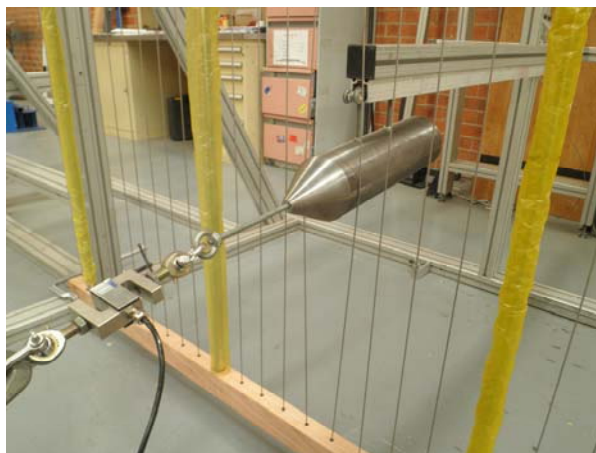
#### **Test sample after pull test:**

**Test description:** Record the force required to pull a conical end test object as per the standard, through the fence panel. The fence panel will be tested in three locations, across the width of the panel at the middle of each third of the panel. The peak force shall be not less than 150N. Please see photos for further detail.

**Test requirement:** Openings in the fencing shall have sufficient strength and rigidity such that 105 mm diameter cone can not pass through the opening under the minimum application of 150 N force.

<b>Peak force (min. 150 Newtons)</b>	<b>Result</b>
<b>Location #1-</b>	<u>181.9</u>	<u>PASS</u>
<b>Location #2-</b>	<u>198.8</u>	<u>PASS</u>
<b>Location #3-</b>	<u>184.0</u>	<u>PASS</u>

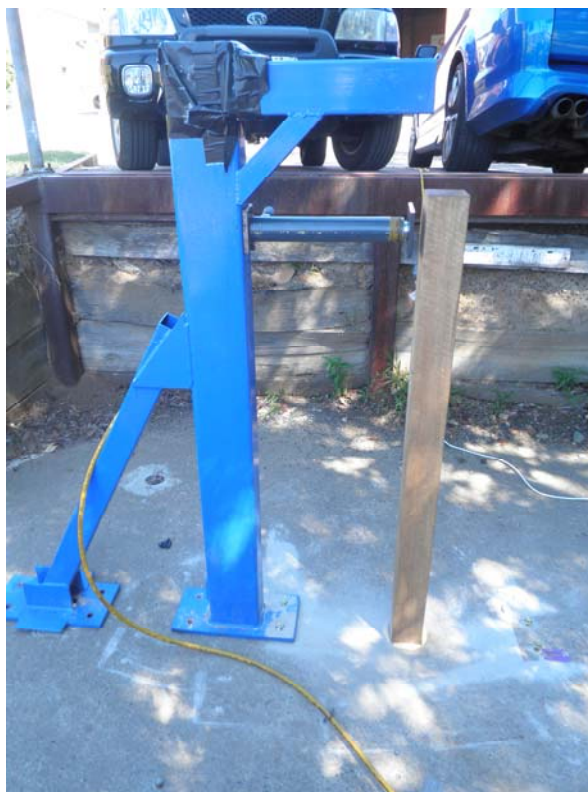
**Test description:** Each post and footing shall withstand a horizontal force of 330N at 1200mm above finished ground level.

**Test requirement:** After loading, there shall be no permanent damage to any post, the footings shall not loosen to impair the effectiveness of the barrier.

**Component tested-** Vertical 90mm square Spotted gum solid hardwood post

**Distance from ground to point of force application:** 1200mm

**Datum measurement:** 400mm

**Force applied:** 330N **Time held:** 30 seconds

**Measurement after 330N applied and released:** 400mm

**Permanent deformation:** 0mm

**Result:** PASS

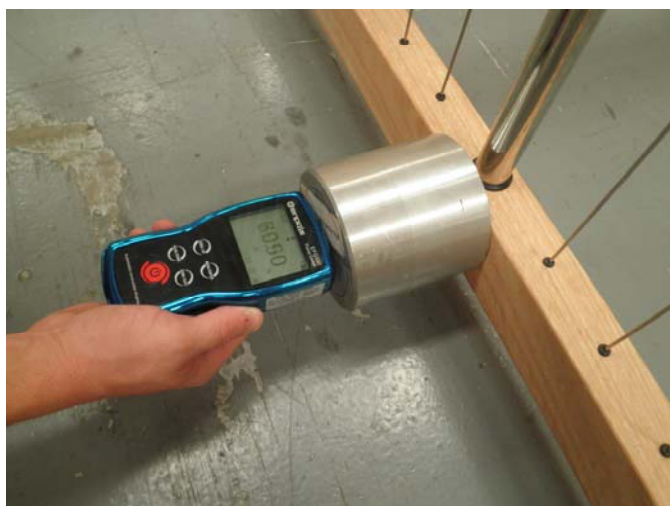
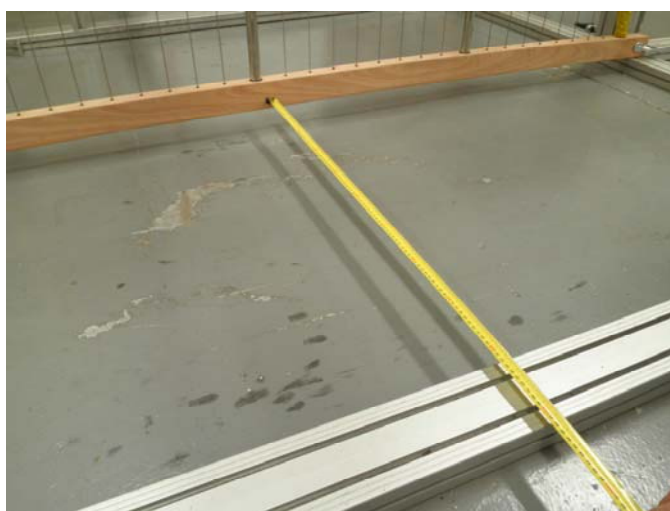
**Horizontal rectangular bottom rail**

**Test description:** A test probe attached to a force gauge is applied to the test sample. Place the flat end of the test probe against the component to be tested. Apply a 50 N pre-load, without shock, to the test object to load the component in the desired direction for 30 seconds. Remove the pre-load and measure a datum point. Apply a force of 330 N, without shock, to the test object in order to load the component in the desired direction for 30 seconds. Remove the test force and inspect the component for breakage or sign of fracture of any component and loosening of any component. Measure and record the amount of deformation of the component, in millimetres. Please see photos for further detail.

**Test requirement:** Structural components shall be capable of sustaining a force of 330 N without any component breaking, showing signs of fracture, loosening, or becoming permanently deformed by more than L/200 mm over its length.

**Component tested-** Horizontal rectangular bottom rail

**Datum measurement:** 912mm

**Measurement after 330N applied and released:** 912mm

**Permanent deformation:** 0mm

**Result:** PASS **Max (L/200):** 13.15mm (2630/200)

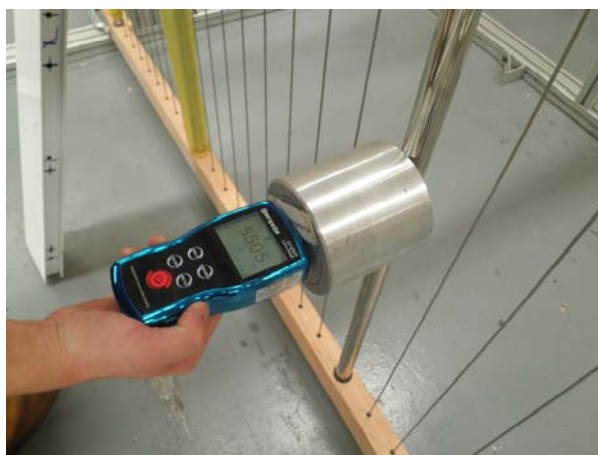
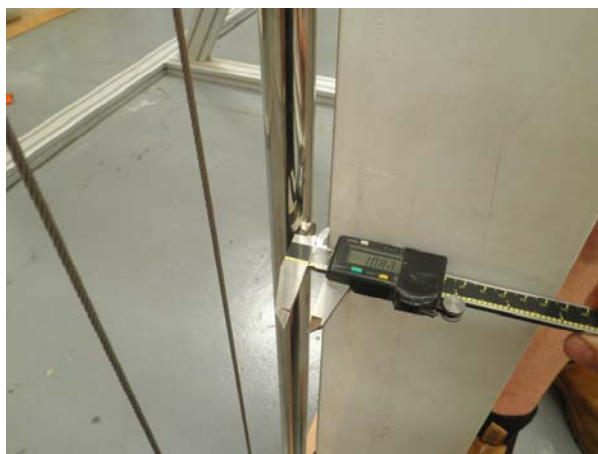
### **Vertical round tube divider**

**Component tested-** Vertical round tube divider

**Datum measurement:** 10mm

**Measurement after 330N applied and released:** 10.5mm

**Permanent deformation:** 0.5mm

**Result:** PASS **Max (L/200):** 4.75mm (950/200)

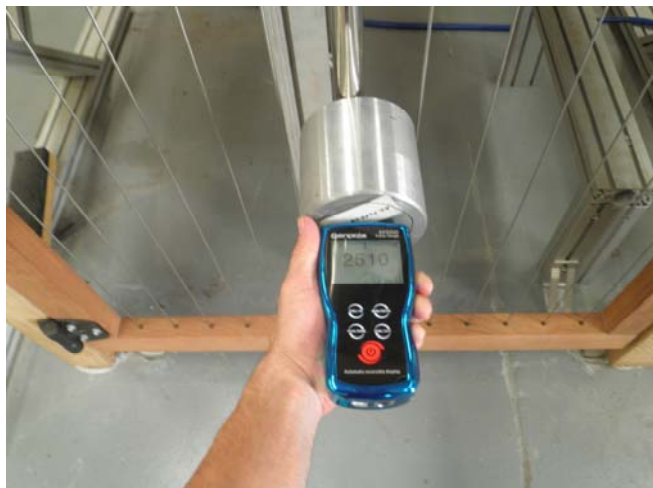
**Gate test**  
**Test A**

**Test description:** A test probe attached to a force gauge is applied to the test sample. Apply a force of 330N to the centre of the gate panel. Apply the same horizontal force to each of the four corners of the gate. Repeat for the other side of the gate. Apply the same horizontal force once more to any part of the gate at, or below, 1200mm from ground level. Inspect the panel for breakage, fracture or permanent deformation and if latch was released during test. Open the gate so it is ajar and separated from the latch post, apply a force of 250N in a vertical direction to the top rail at a point 100mm from the outer edge of the latch stile. Remove force and check the gate automatically closes and the latch operates. Inspect the panel for breakage, fracture or permanent deformation. All forces to be applied for 30 seconds.

#### Test A- Centre of panel

**Datum:** 177mm

**Measurement after test:** 177mm **Permanent deformation:** 0mm

**Maximum allowable (L/200):** 1008/200= 5.04mm

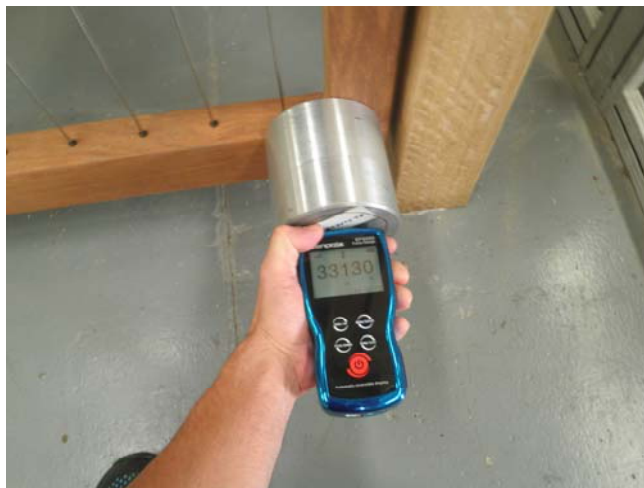
**Test B & C**

#### Test B- Corners of panel- Inside

Test corner	Datum (in mm)	Measurement after (in mm)	Permanent deformation (in mm)	Pass/Fail
1	56	56	0	PASS
2	44	44	0	PASS
3	75	75	0	PASS
4	135	135	0	PASS

#### Test C- Corners of panel- Outside

Test corner	Datum (in mm)	Measurement after (in mm)	Permanent deformation (in mm)	Pass/Fail
1	57	58	1	PASS
2	47	47	1	PASS
3	75	75	0	PASS
4	137	140	3	PASS

**Latch released during test A, B & C? (Y/N):** No

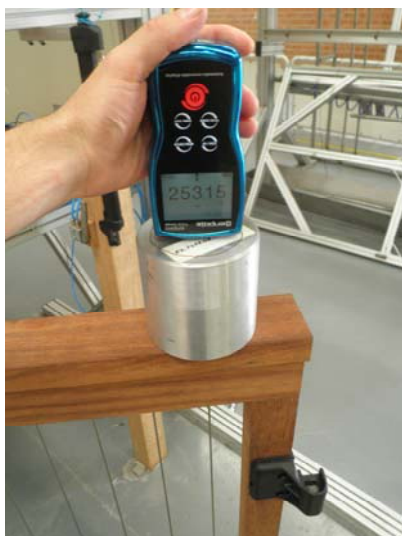
**Test D**

### **Test D- Vertical**

**Force applied:** 250N **Time held:** 30 seconds

**Distance from edge of gate:** 100mm

**Gate closes automatically? (Y/N):** Yes

**Result:** PASS

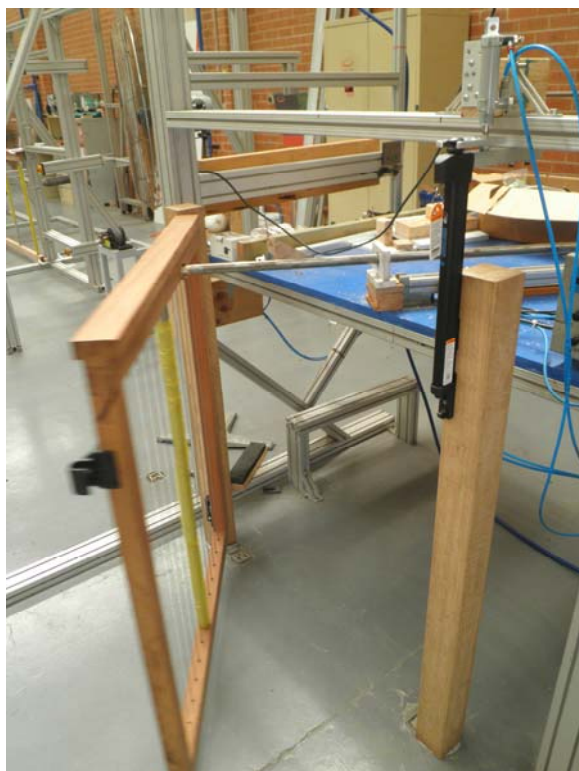
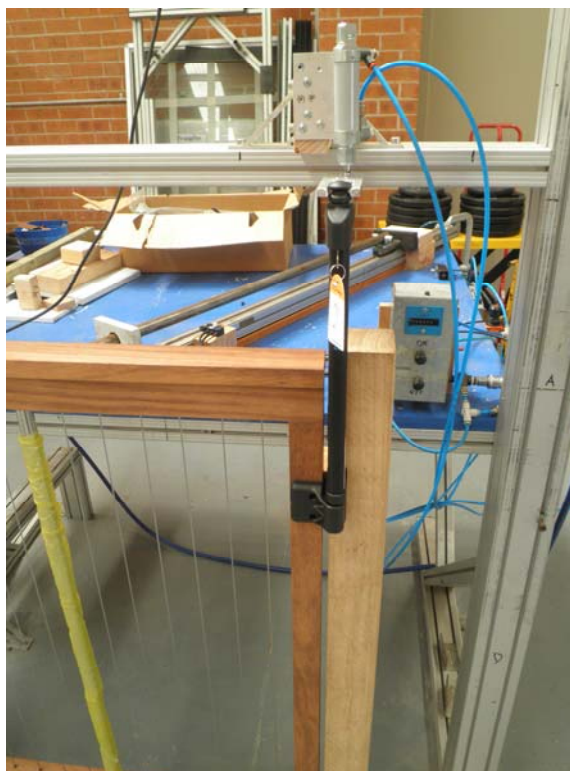
### **Gate durability test**

- (e) Release the gate and allow it to close under the action of the self-closing device.
- (f) Repeat Steps (d) and (e) for a total of 10 000 operations or until the latch fails to operate, whichever occurs first. The latch shall not be lubricated or adjusted during this test.

- (a) Shall be capable of complying with the requirements of Clauses 2.4.1 to 2.4.3 after 10,000 operations; and
- (b) The force required to release the latch shall not be greater than 50 N both before and after the test.

- (a) Number of operations of the gate completed: 10,000
- (b) Does the gate still comply with Clause 2.4 after test complete? Yes
- (c) The force required to release the latch at the start of the test: 22N
- (d) The force required to release the latch at the end of the test: 19N
- (e) Any damage to the gate, hinges, latching device or gate posts at end of the test? No

**Result:** PASS
